## ELECTRONICALLY-CONTROLLED PNEUMATIC BRAKE REVENUE SERVICE TESTS

DOT/FRA/ORD-99/07

July 2001 Final Report This document is available to the U.S. public through the National Technical Information Service Springfield, Virginia 22161

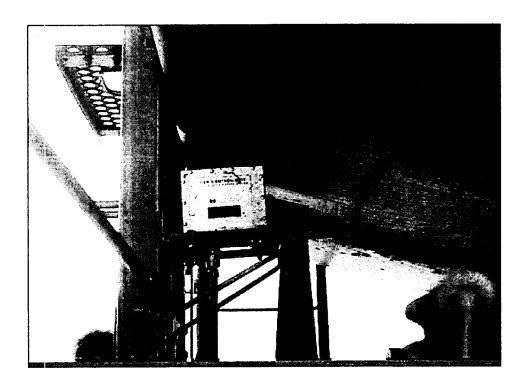
Figure 1. CCD Mounting on Conrail Coal Hopper

An unexpectedly high failure rate of CCDs was experienced during this test. Again, this is contrary to the experience gained on other railroads, where CCD reliability has been much higher than expected. Once the high failure rate was recognized, a complete investigation was carried out as a matter of urgency. First, the failed CCDs were examined by TSM. TSM found that the causes of the high-failure rate on Conrail were two related factors: (1) faulty manufacture and (2) a severe vibration environment. First of all it was found that the CCDs produced over a certain time period contained incorrectly assembled circuit boards. In the TSM design, the transceiver chip pins are bent prior to soldering the chips onto the circuit board. In order to provide added support against vibration, the chips are then glued solidly to the mother board with an epoxy glue. On the defective CCDs, some of the transceiver chips were not glued to the mother boards, and the errors were not caught by the TSM quality control process. These defects would not be revealed during any type of single car or train brake test. All of these faulty CCDs were among the batch of CCDs used on the Conrail test train.

Many of the faulty CCDs failed when they were subjected to high-coupling forces, when emptied cars rolled out of the car dumpers and impacted standing cuts of other empty cars. The unglued transceiver chips failed where the pins were previously bent, due to low-cycle fatigue. To compound the problem, the mounting location of these CCDs was on a shelf bracket welded to a vertical structural post between the center sill and the slope sheet (Figure 1). This subjected the already defective CCDs to considerable shock and vibration, resulting in early CCD failure.

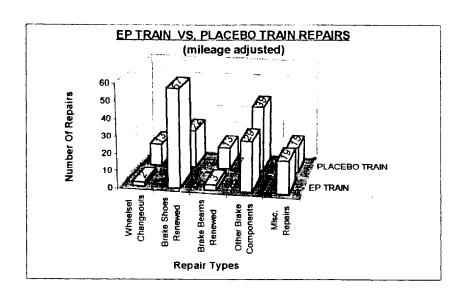
Figure 12 Mileage adjusted repair requirements.

As seen in Figure 12, the wheel change out rate on the EABS equipped cars was much lower than the cars of the placebo train. When adjusted for mileage, the EABS equipped train had two sets of wheels replaced versus thirteen wheel sets for cars of the placebo train. It is worth noting that the two wheel sets changed on the EABS train were from a single car reported to have slid flats caused by a dragging hand brake. Regardless of the braking technology, human error is still present.

The placebo train required four times as many brake beam replacements than did the EABS train during the test period. Most of the brake beams were replaced due to a burnt brake head. However, it is not clear why the conventional brake system would result in more burnt brake heads. This finding appears to be inconsistent with observations made during tests on other railroads.

The repair data suggest that brake shoes wear out much faster on cars in an ECP train than those in a train with conventional air brakes. Nearly a threefold number of brake shoes required replacement on the EABS cars when compared to the cars of the placebo train. It may be attributed to the fact that the train crews had a tendency to use the EABS brake more frequently as it provided better train control than a conventional brake system. This statement is supported by the additional braking witnessed during the in-train evaluation among the eastern segments of the route.

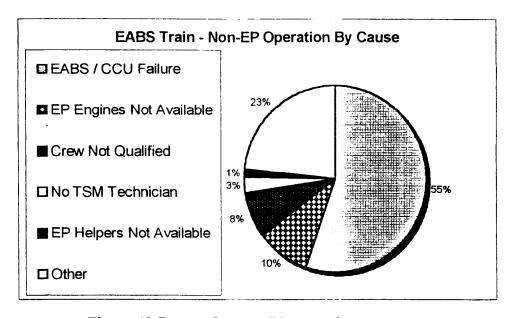
Figure 13 Reason for non-EP operation.

During the test period, two problems developed on the EABS train involving the brake system's CCUs. Some units would unexpectedly lose power and terminate their communications with the Head End Control Unit located inside the cab of the lead engine. This first problem started from the beginning of the test, and in association with failing CCUs, brake lock-up problems were reported on three cars with faulty CCUs.

vertical pillar (end post) which extended upward from the car's center sill to the top of the end slope sheet. Twenty-three CCUs had failed within the first two months of the test. This alarming failure rate was thought to be caused by improper potting of particular circuit components. The retrofitting of the existing CCUs with improved units for the test train was started on August 28. By September 19, all EABS test cars were retrofitted with the new units. Most of the fifty-two round trips were operated in full EP mode; however, the EABS equipment averaged an utilization rate of 73% after providing repairs to the CCUs. The graph of Figure 13 illustrates why the EABS train did not operate completely in electro-pneumatic mode. CCU failure continued to be a major reason for non-EP operation. Consequently, the AAR and TSM personnel conducted a series of

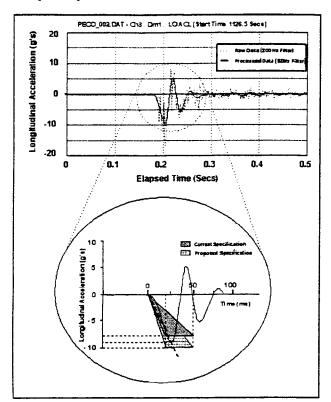
**Exhibit 2. Longitudinal Impact Data**

In each case, the data has been processed by posttest filtering the "raw" data to extract the relevant details. Exhibit 2 illustrates this process for the longitudinal data. The "worst-case" impact data has been filtered at 50 Hz to remove the local structural resonant effects. The resultant "clean" waveform is deemed to represent the impact impulse function. The resultant peak value exceeds the existing 8 g limiting case and, on that basis, a recommended peak-value limit of 10 g has been proposed, with the same ramp time tolerance.

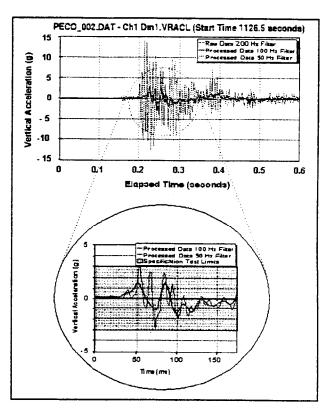
**Exhibit 3. Vertical Acceleration Data**

The "worst-case" vertical acceleration has been processed in a similar manner (Exhibit 3) to extract the rigid car body and fundamental bending frequency components. The effect of local structural resonances, which tend to occur above 60 Hz, are minimized and then eliminated by the filtering operations at 100 Hz and 50 Hz respectively. On the basis of these data, the general vibration level requirement of  $\pm 0.4$  g rms in the performance specification has remained unchanged, although a peak value limit of  $\pm 3$  g within the rms level has been recommended.
